RE: Wetland Delineation, 570 Meriden – Waterbury Road (Rte. 322), Assessor's Parcel ID 024133, Southington, Connecticut.

Wetland / Natural Resource Survey Sketch November 10, 2021

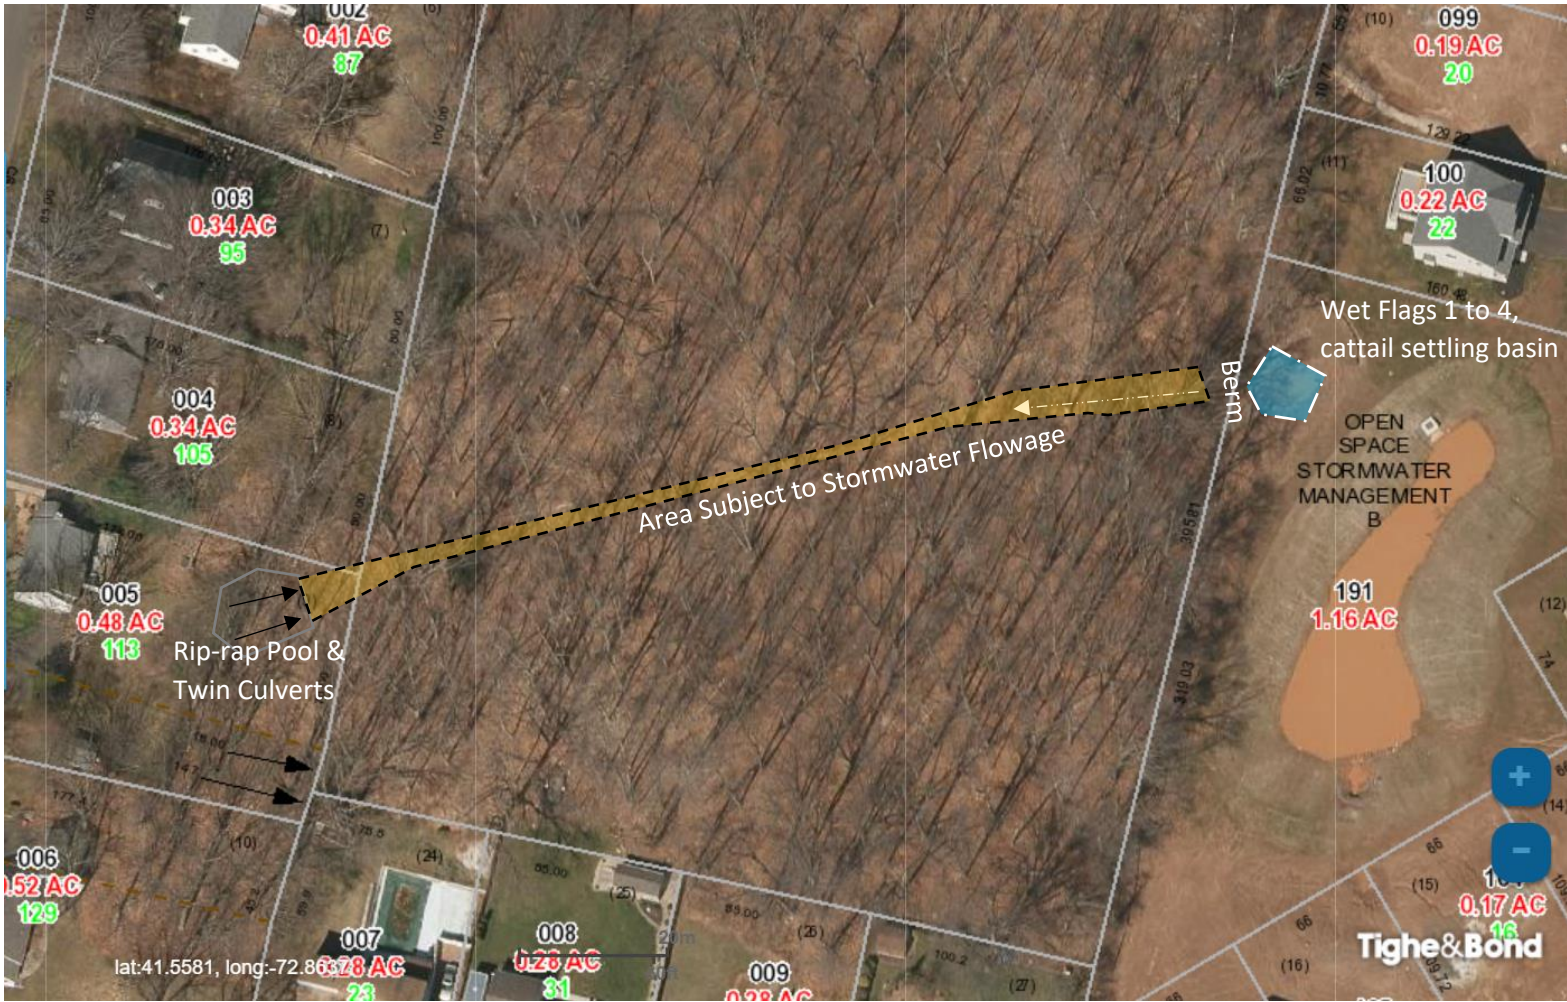
Drainageway – non-jurisdictional

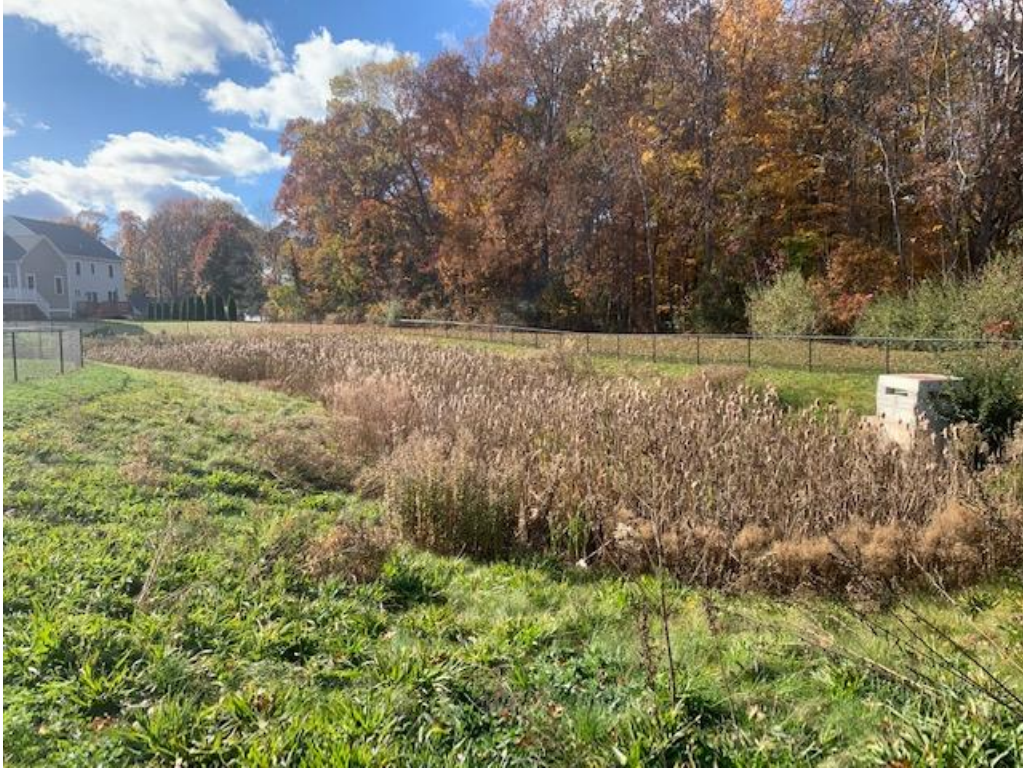
Photo 1: Hillcrest Drive Detention Basin

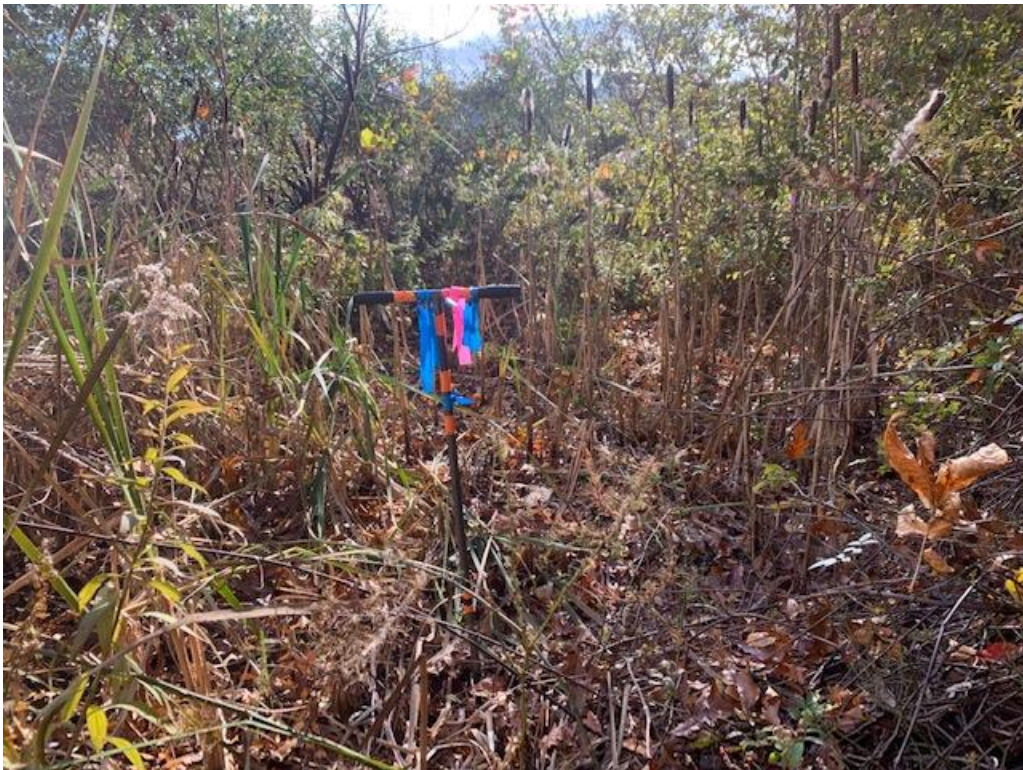
Photo 2: Hillcrest Drive Detention Outlet Settling Basin (offsite)– Flagged as wetland- vegetated by cattail. This man-made feature is segregated from the subject property by an earthen berm.

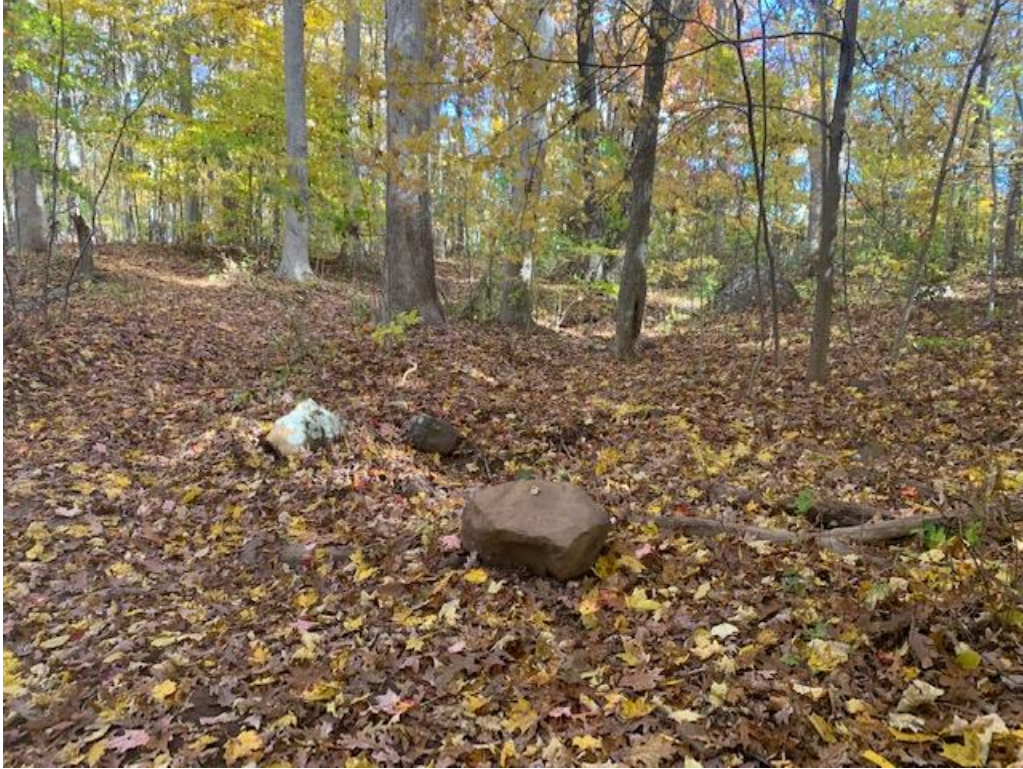
Photo 3: Draw in landscape that is subject to stormwater flowage preceding intense rain events, as seen in the photo there is little evidence of flow path although a cryptic channel does exist if you brush off the forest floor leaf litter, however, the channel lacks persistent flow, has no evidence of wetland soil, and does not have wetland vegetation, therefore the feature does not qualify as a regulated intermittent watercourse.

While the subject erosional feature does have a narrow, shallow channel with evidence of scour, it lacks a predominance of hydrophytic vegetation, is absent of hydric soil development and has demonstrated that base flow does not persist longer than a particular storm event. A second field visit was completed on November 14th, following an intense >1" storm event that occurred overnight Saturday 11/13/2021. The purpose of the field inspection was to witness hydrology conditions within the stream channel following the >1" storm event. On Sunday the day following the storm the channel had showed evidence of flow in the leaf litter, however by morning the entire channel again dry, demonstrating that the sole source of this flashy hydrology is the Hillcrest detention system overflow.

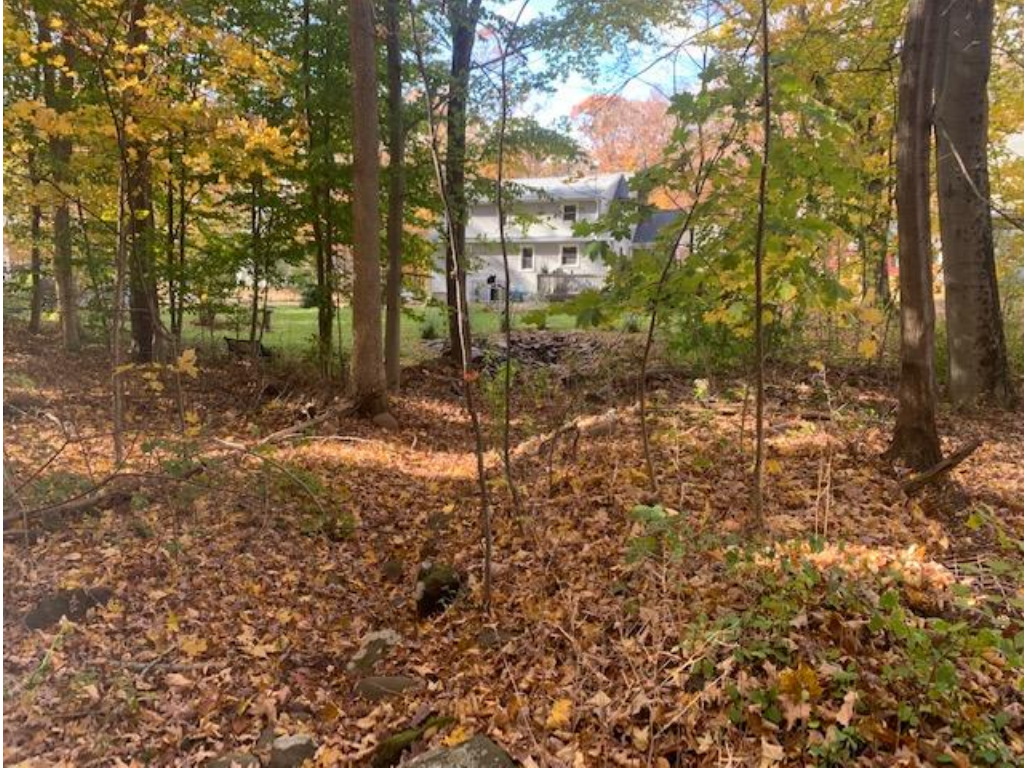
Photo 4: "flow" path heading towards receiving twin culverts behind 113 Blatchley Ave

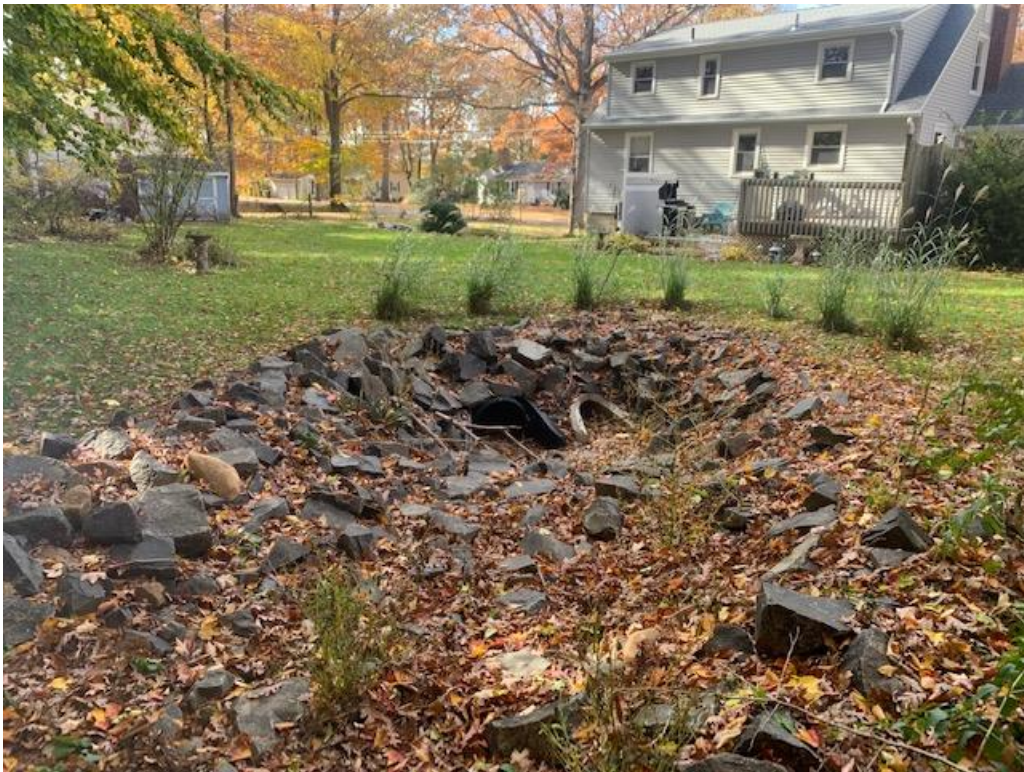
Photo 5: Receiving Culverts behind 113 Blatchley Ave

A notable channel subject to stormwater flowage bisects the southern extents of the property. Stormwater overflow from the Hillcrest subdivision stormwater detention basin cuts across the property (*from east to west*) draining to a collection point consisting of 2 - 15" culverts located in a rip-rap basin in the back yard of 113 Blatchley Ave. This channel is classified an erosional feature subject to storm flowage only and does not qualify as an intermittent watercourse.

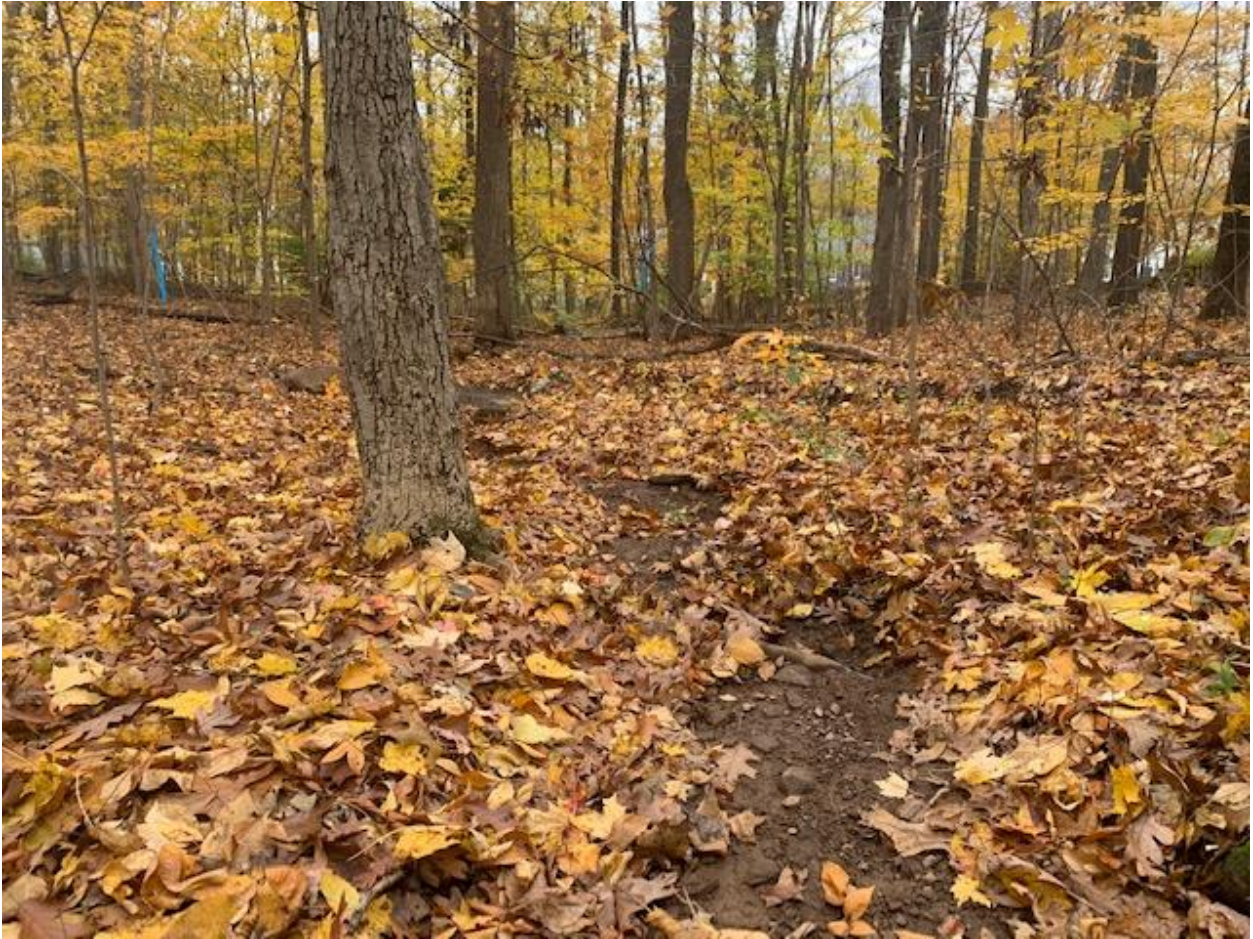
Photo 6: Channel conditions on morning of November 14th, 2021, preceding intense >1" rain event the night before. Note lack of standing or flowing water, evidence of the flashy nature of the hydrology which is tied to the overflow discharge from the Hillcrest subdivision stormwater management system.

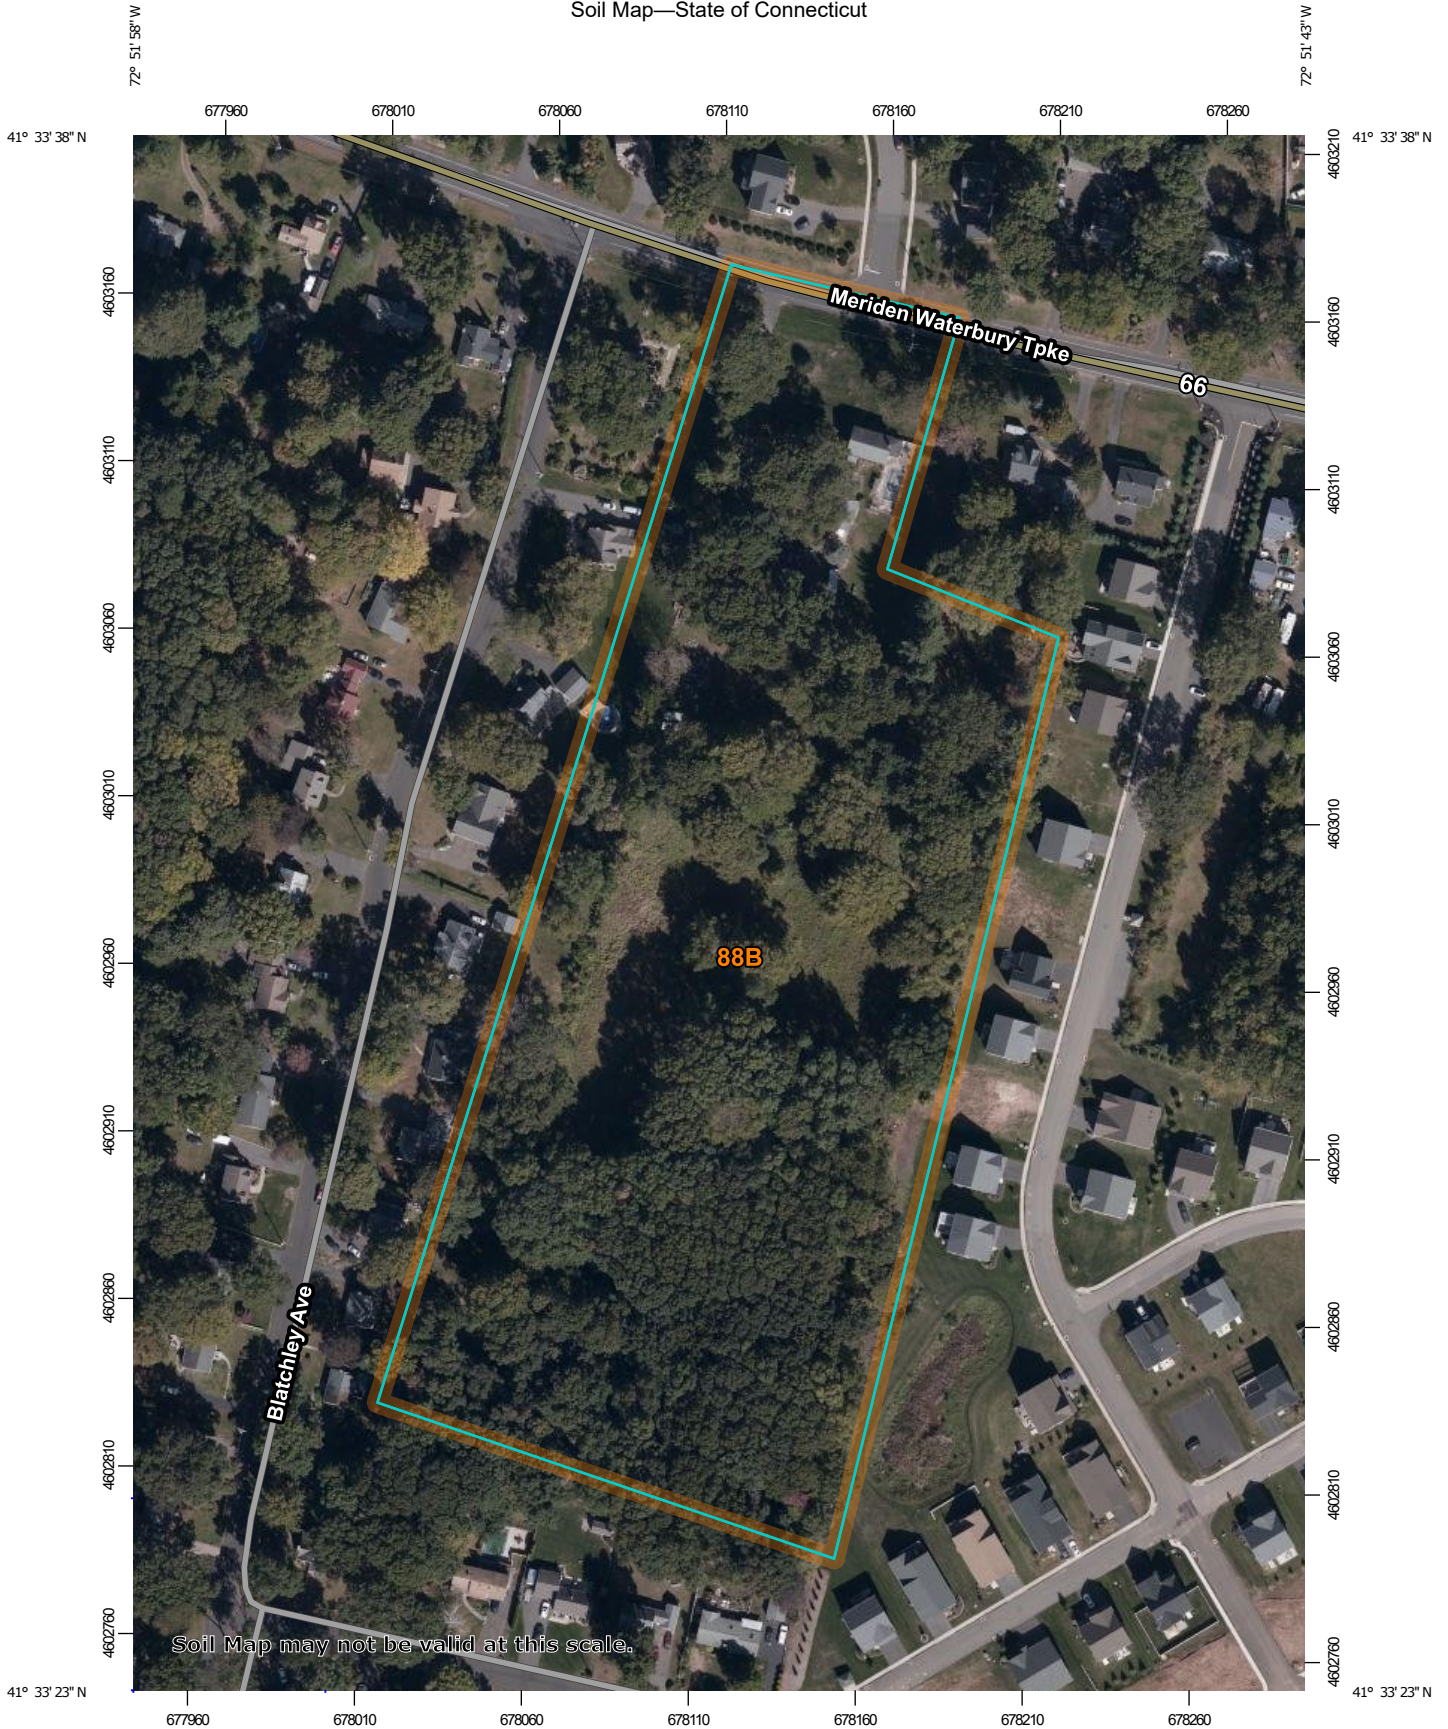
Soil Map—State of Connecticut

The soils mapped and classified on the property belong to the Wethersfield soil series. These well drained upland soils formed from coarse-loamy melt-out till. Generally, Wethersfield soils have about 2 feet of fine sandy loam subsoil over gravely sandy loam parent material. The soils on the property are generally level with slopes ranging from 3-8%.

Map Unit Symbol	Map Unit Name	Acres in AOI	Percent of AOI
88B	Wethersfield loam, 3 to 8 percent slopes, very stony	10.9	100.0%
Totals for Area of Interest		10.9	100.0%
